Radiological Recovery Requirements, Structures, and Operations Research

Volume IV,

Decontamination

Analysis of Selected Sites

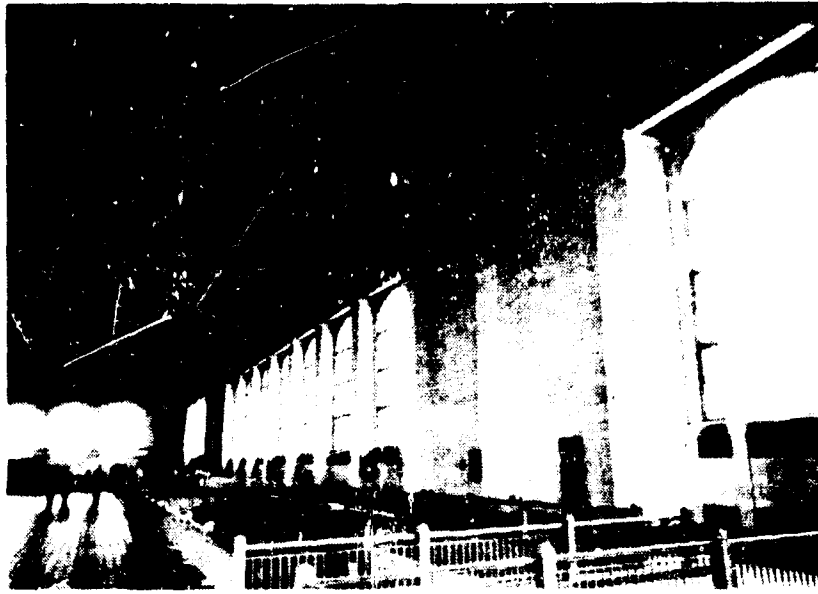
Figure 27

View 1 - Springwells Station -
A View of the Interior of the Pumping
Plant Shcwing the Heavy Wall Construction
and Large Windows

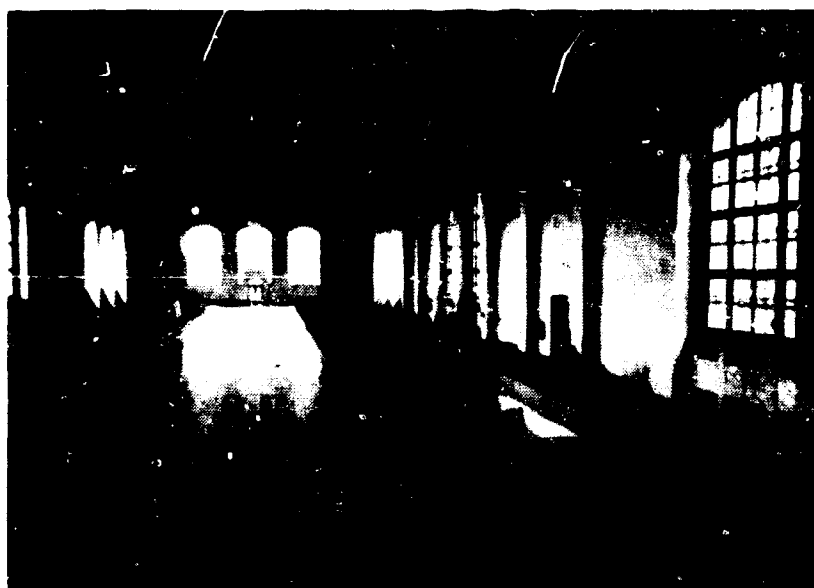
Figure 30

View 4 - Springwells Station -
A View of the Interior of the High Lift
Pump Section of the Pumping Plant

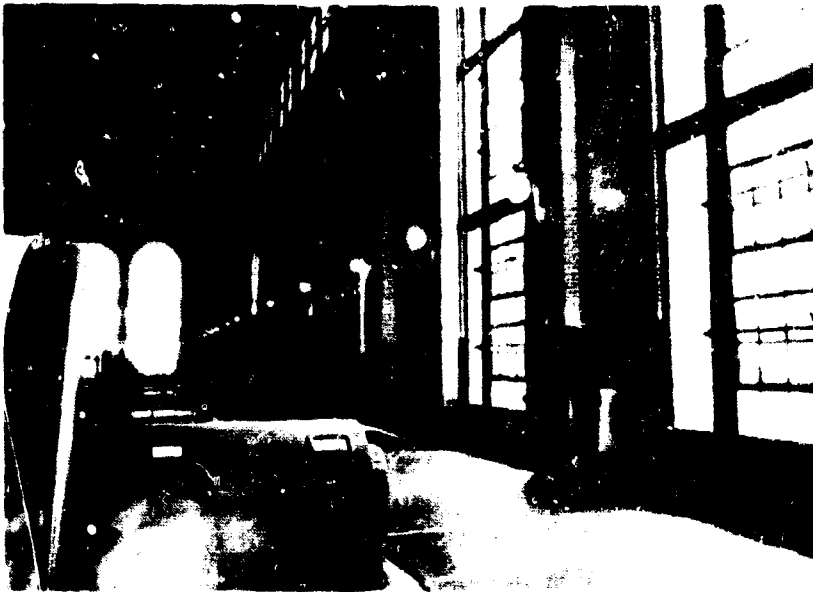
Figure 58

View 3 - Mistersky Power Plant -
A View of the Interior of the Turbine
Room Showing the Relative Size of the
Large Windows

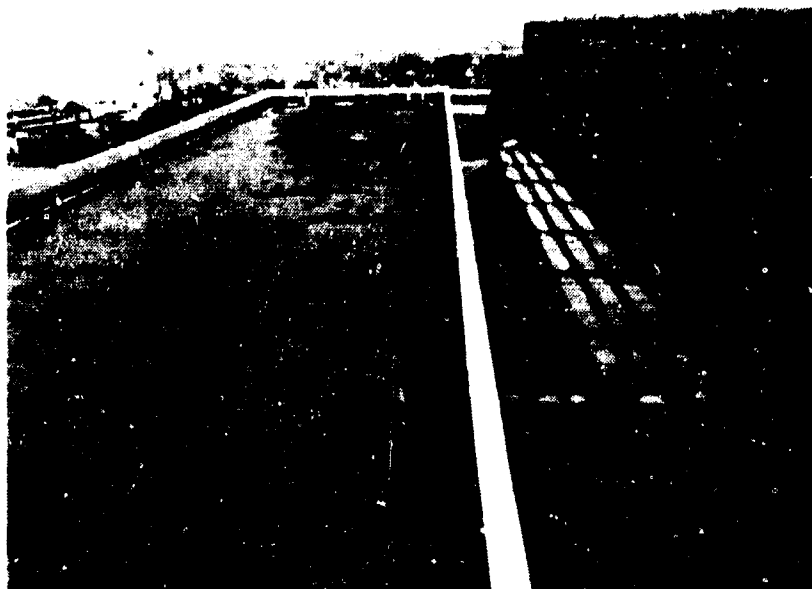
Figure 72

View 17 - Mistersky Power Plant -
A View of the Tar and Gravel Roof
of the Turbine Room

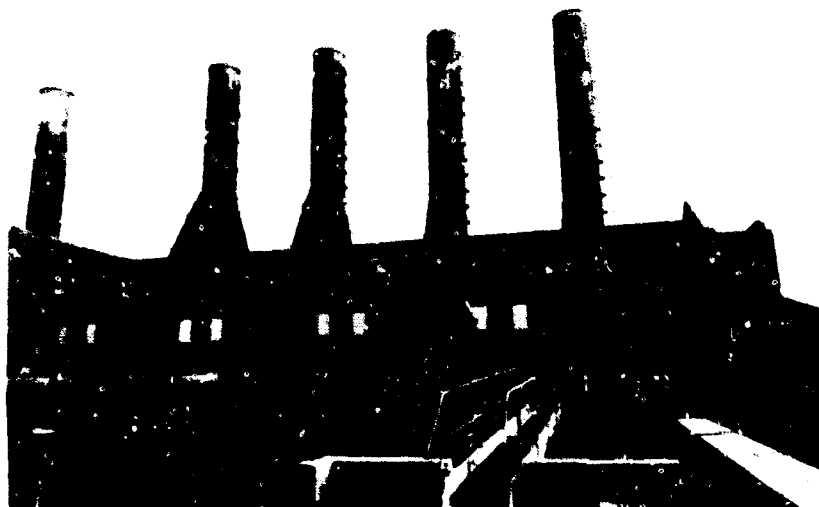
Figure 78

View 23 - Mistersky Power Plant -
A View of the Upper Roofs Over the
Boiler Rooms Showing the Large
Obstructions to Decontamination

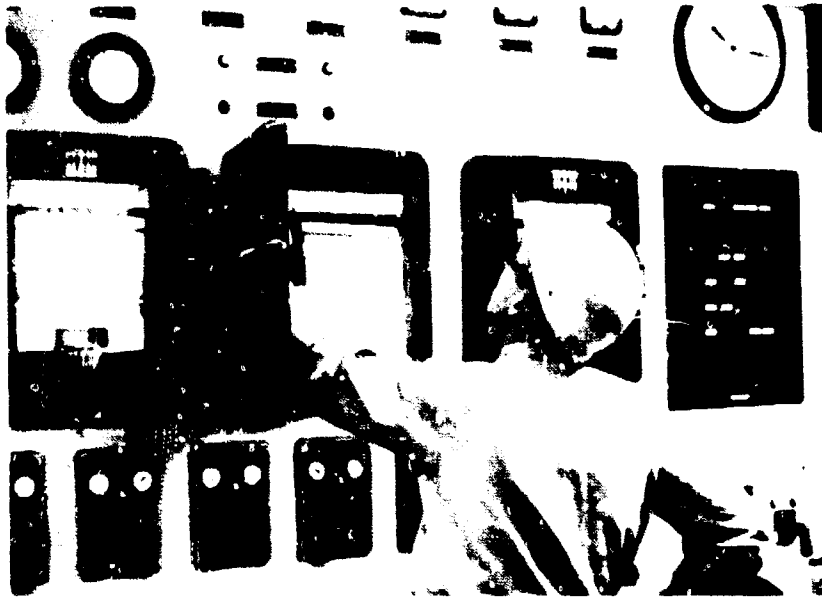
Figure 81

View 26 - Mistersky Power Plant -
A View of the Remote TV Control
to the Screen House
